De Grolsch Veste stadium failure

Sean Brady provides an overview of the technical and human factors that contributed to the partial collapse of Dutch football team FC Twente's stadium roof.

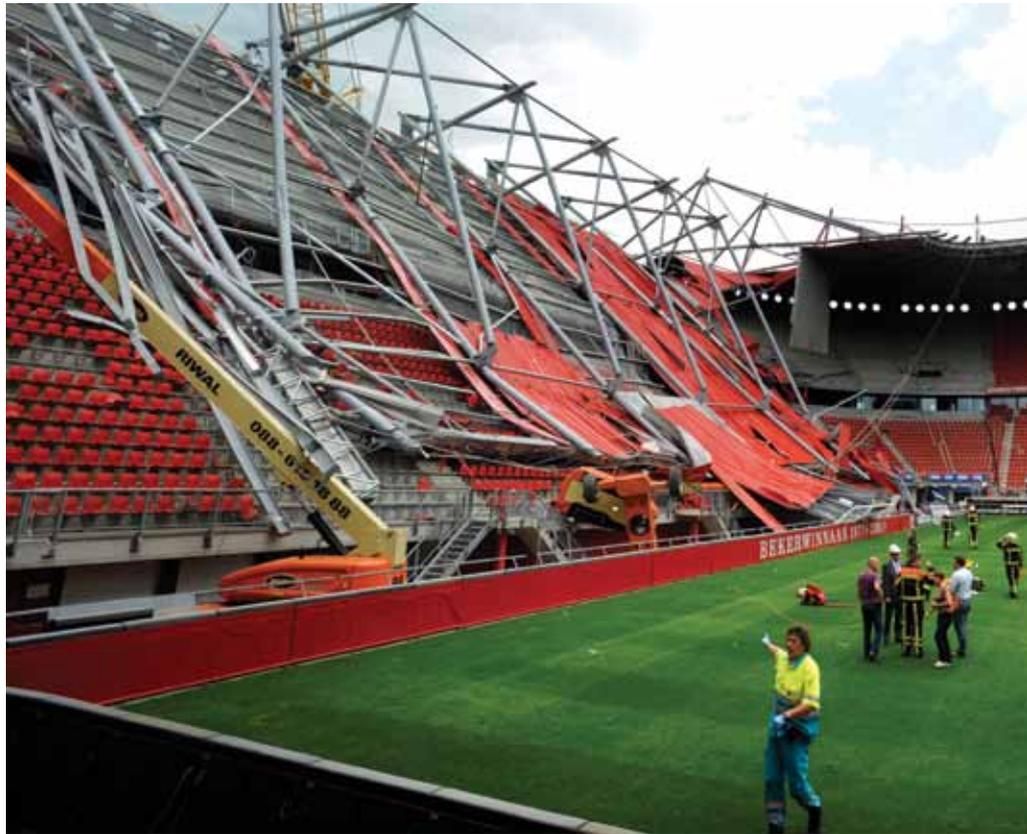
"Tellingly, the last of these cables was removed on the day of the failure"

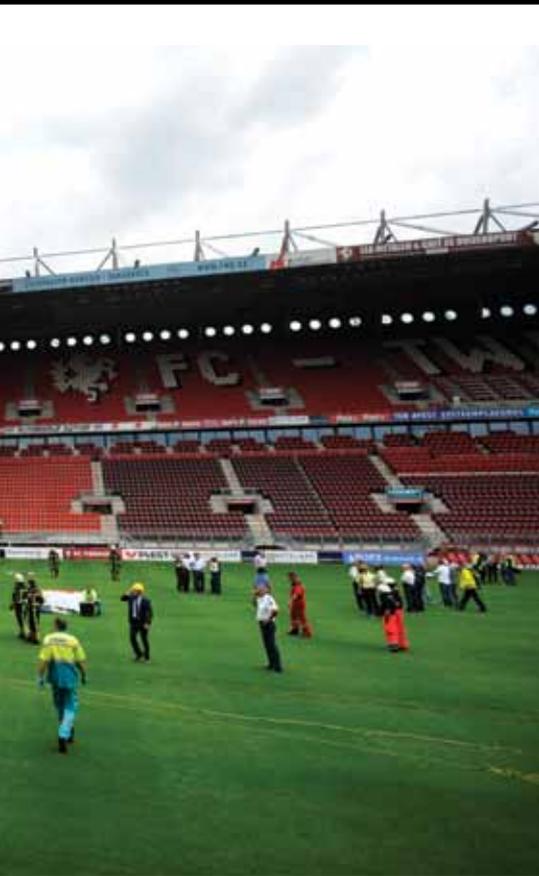
on 7 July 2011, construction workers were working both on top of and beneath the extended roof structure when it collapsed, resulting in 12 workers falling from a height. Two were killed and nine injured, some critically.

Figure 1
Collapse resulted in two fatalities and nine injuries

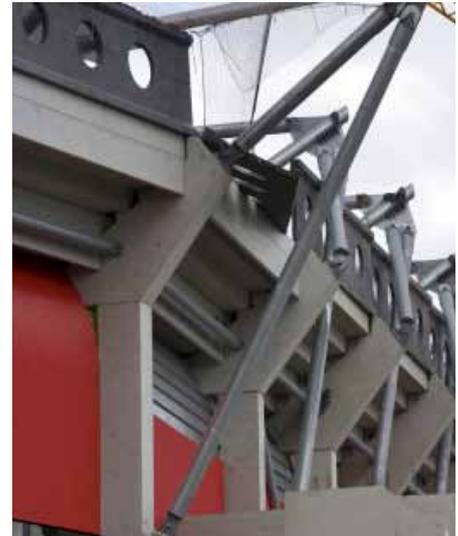
The investigation concluded that the main contractor allowed work that should have been undertaken sequentially, to be undertaken simultaneously. It appears that because of time pressure associated with ensuring the stadium was 'football-ready', the main contractor abandoned the original construction sequence. The investigation

determined that 'the main contractor did not assess whether these changes would affect the safety of the workers performing the work'. Fundamentally, the investigation concluded that the main contractor put an incomplete steel structure into use without checking if it was safe to do so.

Figure 3
Technical and human factors contributed to failure

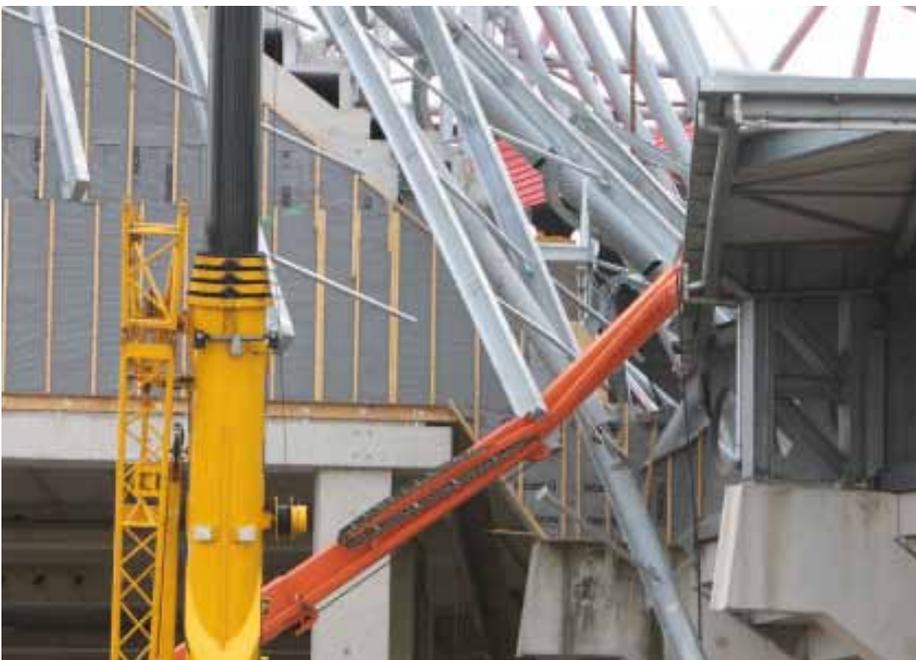
From a technical perspective, the investigation concluded that the cause of the failure was the insufficient stability of the incomplete roof structure, with three key factors playing a role in the collapse:

- Elements required for stability were missing from the roof structure. Temporary bracing, in the form of steel cables, was utilised to maintain stability during construction, and it appears that these cables were removed before the permanent bracing was complete. Tellingly, the last of these cables was removed on the day of the failure
- The incomplete roof was subject to

excessive loading. Prior to the roof's completion, the main contractor permitted the installation of a video wall, suspension bridges, and some roof sheeting. The investigation identified that this additional loading was sufficient to collapse the incomplete structure

- Dimensional deviations in the concrete structure resulted in a mismatch between the concrete and steel structures. The investigation found that these deviations, combined with a lack of ability to adjust the steel structure, necessitated the steel contractor to 'force fit' some of the steel components, thus introducing additional loading into the structure, and reducing the overall load carrying capacity of the roof

Figure 2
Insufficient stability of roof structure
