# West Gate Bridge collapse – the story of the box girders

**Sean Brady relates the failure of several box-girder bridges of the 1960s and 1970s and explains how these led to new design rules and workmanship guidance.**

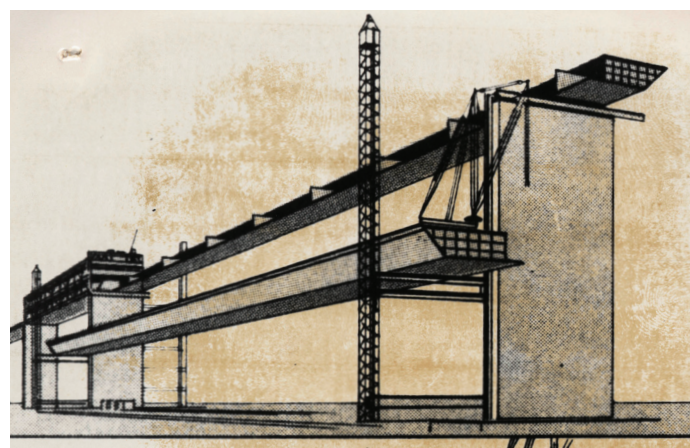
**Figure 1**  
Diagram showing half-span being lifted into position

The contractor was fabricating half of each span on the ground – imagine cutting each span along its length, leaving two half-width spans. Each of these half-spans was then, in turn, lifted 50m up in the air and slid into position (Figure 1). In this way, the contractor halved the load for each lift – albeit doubling the number of lifts. By the time of the Milford Haven collapse, the east and west spans of the West Gate Bridge, each 112m long, were ready for erection.

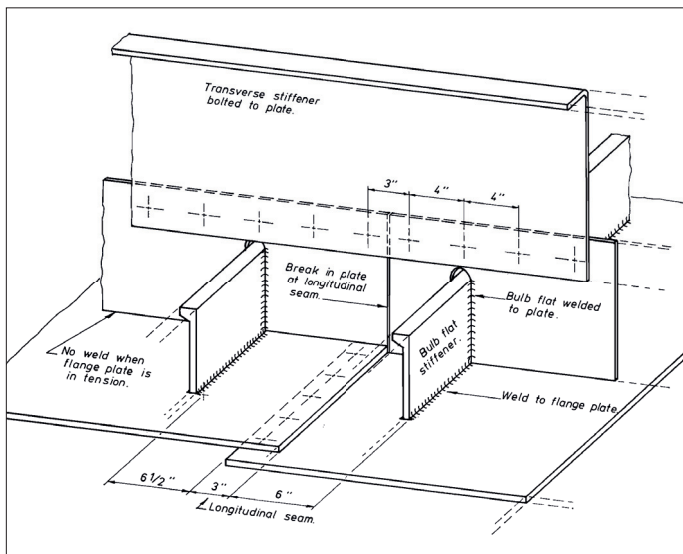
Figure 2  
Detail of stiffeners  
to plating<sup>2</sup>

The buckle occurred because of the decision to lift each half-span separately. While the free flange was stiffened longitudinally and transversally, there was a problem with both sets of stiffeners (Figure 2). The transverse stiffeners didn't have the necessary stiffness to restrain the longitudinal stiffeners, and this lack of restraint resulted in the longitudinal

stiffeners having a longer effective length (and therefore a lower buckling load) than anticipated. Further, the longitudinal stiffeners had joints every 16m. These joints consisted of a flat splice plate bolted to each stiffener, but this plate had a smaller cross-sectional area than the longitudinal stiffeners and it bridged a gap of 318mm between the points where one stiffener ended and the other began. In addition, the plate was offset from the stiffeners, and this eccentricity, in combination with a smaller splice plate area and the gap between the stiffeners, created a point of weakness at every joint in the longitudinal stiffeners.

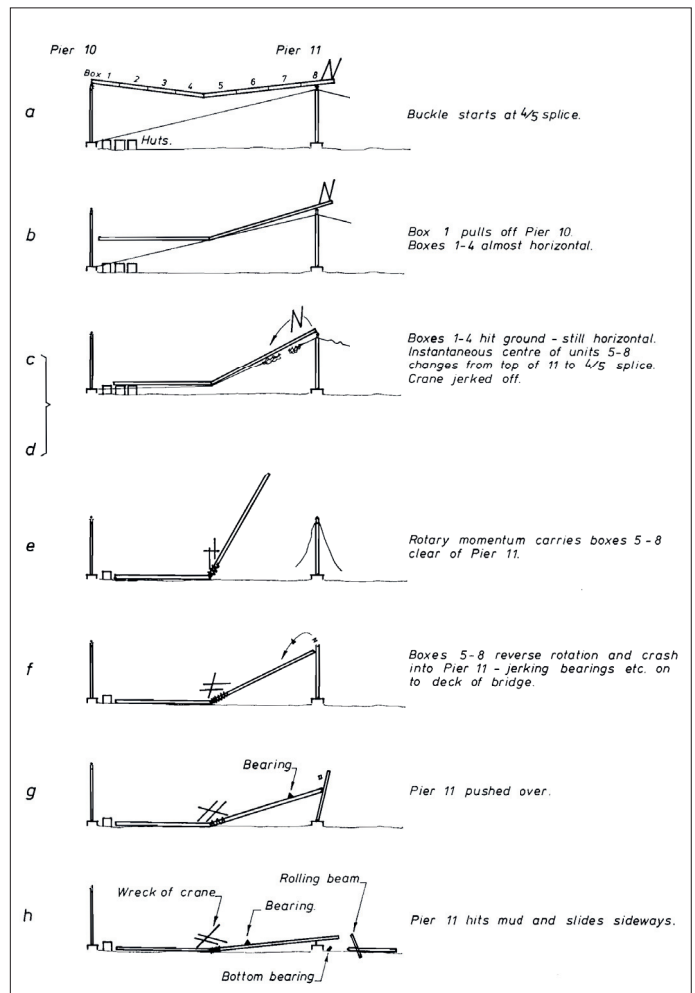
Figure 3  
Dynamics of failure<sup>2</sup>

They began removing bolts. The stresses in the remaining part of the top flange began to increase – with every bolt removal the neutral axis was being lowered and there was a loss of cross-sectional area in the section. They removed 16 bolts. Then kept going. When 37 bolts were removed, the bridge had had enough: its net section failed and the remaining bolts in the top flange sheared. The span became a mechanism (Figure 3). The left-hand half-span began to drop downwards. The load then shifted to the right-hand half-span because it was partially connected. Then the entire span collapsed 50m to the ground below (Figures 4 and 5). There were 35 fatalities.

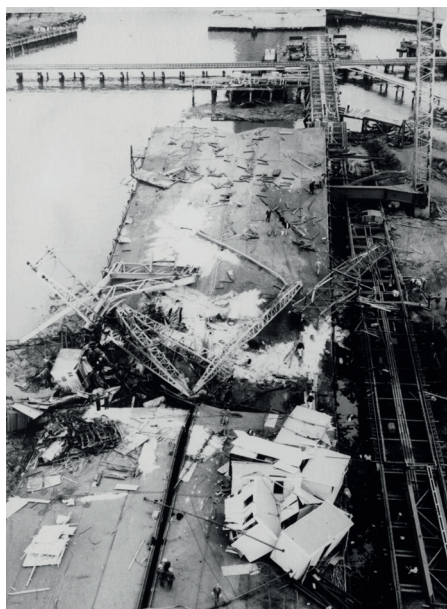
**Figure 5**  
Bridge span after collapse

The Milford Haven collapse was initiated by an inadequately stiffened diaphragm – the designers at the time were unaware of the complex behaviour of diaphragm plates, and the design codes reflected this lack of knowledge. The West Gate collapse – as we know – was the result of a variety of causes, but central was a lack of understanding of the behaviour of stiffening plates.

There followed a flurry of activity after the four known failures. In Australia, there was a Royal Commission into the West Gate Bridge failure; and, following the collapse of the bridge at Milford Haven, the Merrison Committee produced an interim report with new design rules and workmanship guidance. This research was put into practice by the industry and existing bridges were strengthened.
