The I-35W Highway Bridge collapse: les

From its initial design to the stockpiling of materials during subsequent renovation, Sean Brady details a succession of failures and missed opportunities that resulted in the catastrophic collapse of a highway bridge in Minnesota.

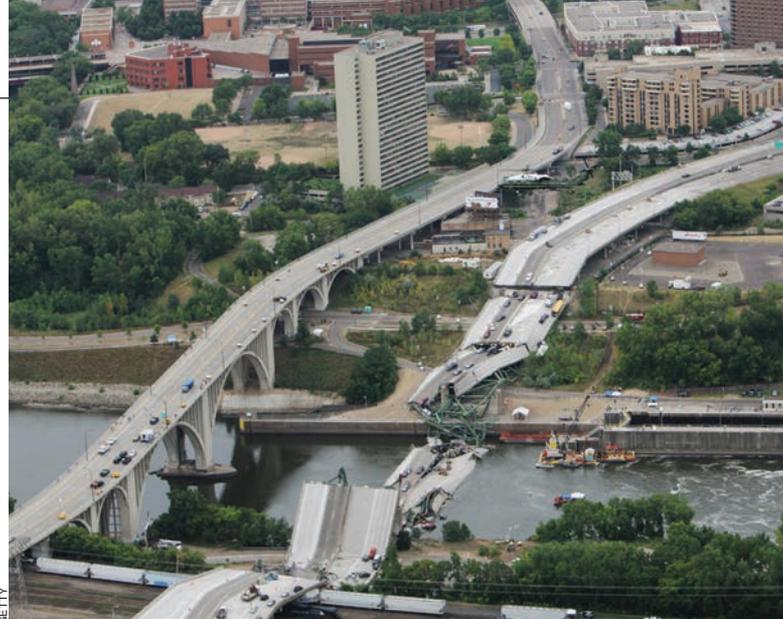
As we now know, this pour never took place. At 6:05pm a 300m section of the main truss span collapsed, with a 140m section falling 33m into the river below (Figure 1). A total of 111 vehicles were on the collapsed section, and only 17 were recovered. Tragically, 13 people lost their lives and 145 were injured.

The subsequent National Transportation Safety Board's (NTSB) investigation would identify undersized gusset plates, due to a design error, in combination with recent increases in dead load and live load as the cause of the failure¹. This article explores how the load increases

Figure 1
Collapsed section of I-35W Highway Bridge
